**Flood Control Project Maintenance
Levee Inspections**
LMA District Cover Sheet
Spring 2018 Levee Inspection Results

Reclamation District No. 0070 Meridian

Spring 2018 Levee Inspection Results

Waterway			Bank	Unit Miles
Unit No. 01 Sutter Bypass			Right	7.92
	Spring (March - May)	Summer (June - August)	(September - November) Fall	Winter (December - February)
Unit Maintenance Rating (Fall Only)				
Date of Inspection	3/15/2018 - 3/15/2018			
DWR Inspector	Bob Duffey			
Accompanied By	Andy Duffey

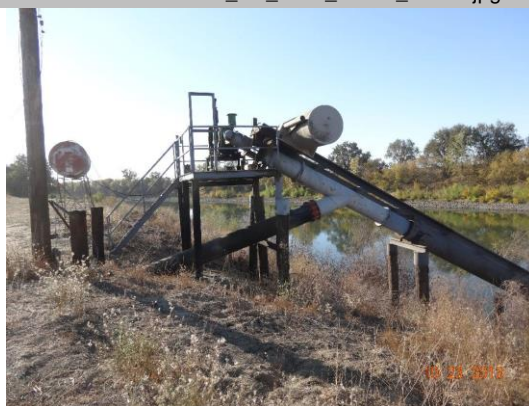
Photo 2 of 3 : UCIP_SP_2018_46424_42049.jpg

FS_ID:46424
 DS_ID:21386
 EP_NO: 9994
 Repair Type: Non-Urgent
 Crossing Status: Found
 UCIP Comments: 07/28/2015 System was running during site visit. Damage to landward side has been repaired. No records available to determine cause of erosion--monitor. No other issues observed during site visit. 10/23/2013 Erosion visible on landward side behind concrete headwall. Plastic sheeting has been placed to protect slope. Need to determine cause for erosion, is pipe leaking? Pipe wall on landward side has deteriorated significantly that the wall is gone. Owner will need to coordinate with DWR inspector and CVFPB to address issue. Recommend notifying owner to stop using crossing until issue has been addressed. This crossing is referenced in the USACE Periodic Inspection as item USACE_CESPK_MRD2_2012_p_0324.
 FIELD_STRUCT_DESC: 20-inch coated steel irrigation discharge pipe on the waterside (WS) and 24-inch coated steel irrigation discharge pipe on the landside (LS) through the levee, 12.5 feet below the crown. Pipe is concrete encased under the crown, between the shoulders. Slide gate in a metal well on the WS slope. Pump on a pile structure in the stream. Concrete discharge box at the LS toe. Service pole on the WS slope. (Plans for the installation of an irrigation pumping plant and appurtenant electrical power line across the levee authorized under Permit No. 1202, 19 - Hannah R. Jacobs. Retention of a 24-inch concrete encased steel pipe through the levee, 12.5 feet below the crown, a pump, a slide gate, and a concrete discharge box authorized under Automatic Board Order (ABO) issued as Permit No. 9994, 1974 - R. X. Ranch Company). [Additional Reference(s): DWR Levee Log, 2007. USACE Sacramento O&M Manual 134, June 1953, (Station 610+84)].

Pipe and pump set up on waterward side.

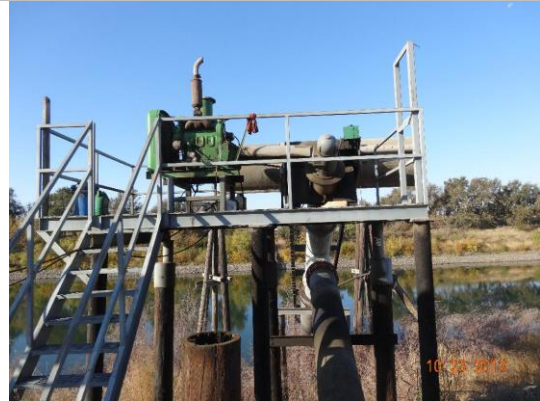
Photo 3 of 3 : UCIP_SP_2018_46424_42047.jpg

Comment Code						
Inspector Comment						
FS_ID:46424 DS_ID:21386 EP_NO: 9994 Repair Type: Non-Urgent Crossing Status: Found UCIP Comments: 07/28/2015 System was running during site visit. Damage to landward side has been repaired. No records available to determine cause of erosion--monitor. No other issues observed during site visit. 10/23/2013 Erosion visible on landward side behind concrete headwall. Plastic sheeting has been placed to protect slope. Need to determine cause for erosion, is pipe leaking? Pipe wall on landward side has deteriorated significantly that the wall is gone. Owner will need to coordinate with DWR inspector and CVFPB to address issue. Recommend notifying owner to stop using crossing until issue has been addressed. This crossing is referenced in the USACE Periodic Inspection as item USACE_CESPK_MRD2_2012_p_0324. FIELD_STRUCT_DESC: 20-inch coated steel irrigation discharge pipe on the waterside (WS) and 24-inch coated steel irrigation discharge pipe on the landside (LS) through the levee, 12.5 feet below the crown. Pipe is concrete encased under the crown, between the shoulders. Slide gate in a metal well on the WS slope. Pump on a pile structure in the stream. Concrete discharge box at the LS toe. Service pole on the WS slope. (Plans for the installation of an irrigation pumping plant and appurtenant electrical power line across the levee authorized under Permit No. 1202, 19 - Hannah R. Jacobs. Retention of a 24-inch concrete encased steel pipe through the levee, 12.5 feet below the crown, a pump, a slide gate, and a concrete discharge box authorized under Automatic Board Order (ABO) issued as Permit No. 9994, 1974 - R. X. Ranch Company). [Additional Reference(s): DWR Levee Log, 2007. USACE Sacramento O&M Manual 134, June 1953, (Station 610+84)]. FS Date: 7/28/2015 3:46:00 PM

Stairs and platform located on waterward side.

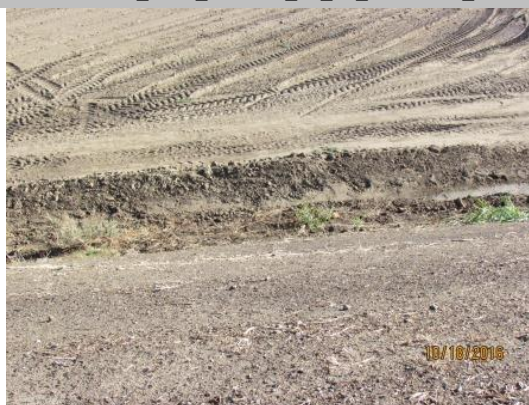
Photo 1 of 1 : SP_2018_RD0070_30_57_20180305_00008.jpg

LM Start	7.18	Rating **	M	Issue No.	57
LM End	7.18	Issue Type +	En	Location *	LS
Category	Earthen Levee			GPS Latitude/Longitude	
				Start	End
Item	Encroachments			39.128114 °	39.128114 °
				-121.923429 °	-121.923429 °
DWR ID	DWR_RD0070_02_f_2016_57				
Comment Code					
DT : Ditch					
Inspector Comment

View of a ditch along the landside toe.

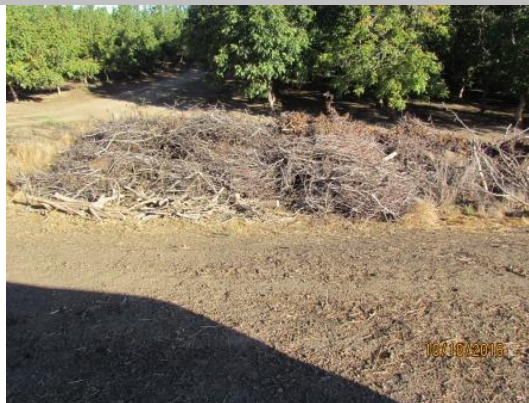
Photo 1 of 1 : SP_2018_RD0070_30_58_20180305_00009.jpg

LM Start	7.62	Rating **	U	Issue No.	58
LM End	7.64	Issue Type +	En	Location *	LS
Category	Earthen Levee			GPS Latitude/Longitude	
				Start	End
Item	Encroachments			39.124448 °	39.124493 °
				-121.917505 °	-121.917090 °
DWR ID	DWR_RD0070_02_f_2016_58				
Comment Code					
PR : Prunings					
Inspector Comment					
Remove prunings from the landside toe.

View of the prunings along the landside toe.

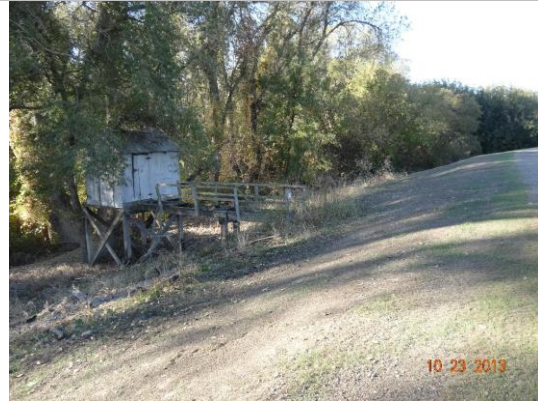
Photo 1 of 3 : UCIP_SP_2018_23966_42128.jpg

Comment Code						
Inspector Comment						
FS_ID:23966 DS_ID:21387 EP_NO: 9966 Repair Type: Non-Urgent Crossing Status: Indicator Found UCIP Comments: Pipe daylight at waterward side blocked. Unable to determine if connection is present--need to contact owner to determine if owner plans to use. If crossing is no longer in use owner will need to coordinate with DWR inspector and CVFPB to remove according to Title 23 requirements. Unable to determine if crossing is in use. This crossing is referenced in the USACE Periodic Inspection as item USACE_CESPK_MRD2_2012_p_0371. FIELD_STRUCT_DESC: 10-inch coated steel irrigation discharge pipe and 1.5-inch electrical conduit of an unknown material through the levee, 12 feet and 8 feet below the crown, respectively. Pipe is concrete encased under the crown, between the shoulders. Concrete cutoff wall under each shoulder. Pump and gate valve on a pile structure in the stream. Walkway to the pump. Concrete standpipe on the landside (LS). (Retention of a 24-inch corrugated metal drainage pipe through the levee, 13 feet below the crown, a flap gate, and two concrete headwalls authorized under Automatic Board Order (ABO) issued as Permit No. 11496, 1976 - Earl Foutch). [Additional Reference(s): DWR Levee Log, 2007. USACE Sacramento O&M Manual 134, June 1953, (Station 689+50)]. FS Date: 10/23/2013

Pump house located on waterward side.

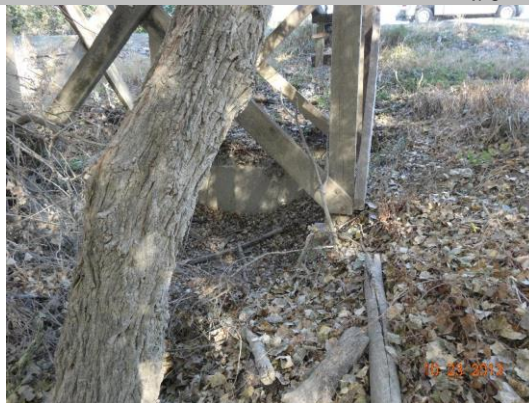
Photo 2 of 3 : UCIP_SP_2018_23966_42126.jpg

FS_ID:23966
DS_ID:21387
EP_NO: 9966
Repair Type: Non-Urgent
Crossing Status: Indicator Found
UCIP Comments: Pipe daylight at waterward side blocked. Unable to determine if connection is present--need to contact owner to determine if owner plans to use. If crossing is no longer in use owner will need to coordinate with DWR inspector and CVFPB to remove according to Title 23 requirements. Unable to determine if crossing is in use. This crossing is referenced in the USACE Periodic Inspection as item USACE_CESPK_MRD2_2012_p_0371.
FIELD_STRUCT_DESC: 10-inch coated steel irrigation discharge pipe and 1.5-inch electrical conduit of an unknown material through the levee, 12 feet and 8 feet below the crown, respectively. Pipe is concrete encased under the crown, between the shoulders. Concrete cutoff wall under each shoulder. Pump and gate valve on a pile structure in the stream. Walkway to the pump. Concrete standpipe on the landside (LS). (Retention of a 24-inch corrugated metal drainage pipe through the levee, 13 feet below the crown, a flap gate, and two concrete headwalls authorized under Automatic Board Order (ABO) issued as Permit No. 11496, 1976 - Earl Foutch). [Additional Reference(s): DWR Levee Log, 2007. USACE Sacramento O&M Manual 134, June 1953, (Station 689+50)].

Concrete headwall located on waterward side.

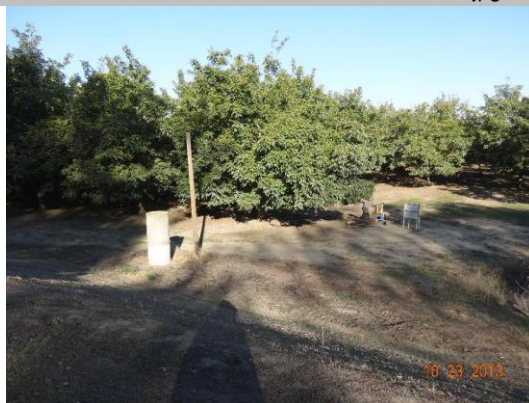
Photo 3 of 3 : UCIP_SP_2018_23966_42127.jpg

Stand pipe located on landward side.

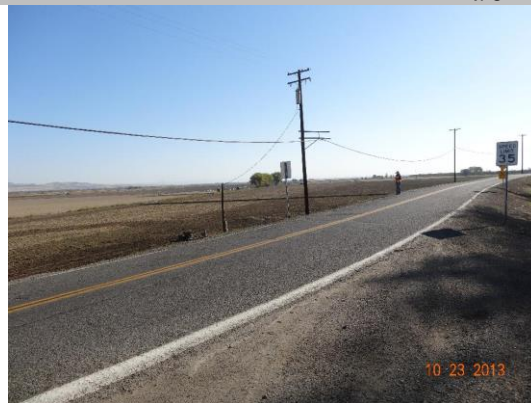
Photo 1 of 3 : UCIP_SP_2018_24191_42677.jpg

Comment Code					
Inspector Comment					
FS_ID:24191 DS_ID:21389 EP_NO: 1264 Repair Type: Non-Urgent Crossing Status: Indicator Found UCIP Comments: Need to coordinate with owner to determine status of crossing. If crossing is no longer in use owner will need to contact the CVFPB to comply with Title 23. This crossing is referenced in the USACE Periodic Inspection as item USACE_CESPK_MRD2_2012_p_0124. FIELD_STRUCT_DESC: *ABANDONED* 10-inch (not 14-inch as specified in the permit) irrigation discharge pipe of an unknown material through the levee, 5 feet below the crown. Pump on the waterside (WS). Double concrete discharge box at the landside (LS) toe. (Plans for installing an irrigation pumping plant and a 14-inch steel discharge pipe through the levee authorized under Permit No. 1264, 1948 - Robert Chesney). [Additional Reference(s): DWR Levee Log, 2007]. FS Date: 10/23/2013

View of levee crown at crossing.

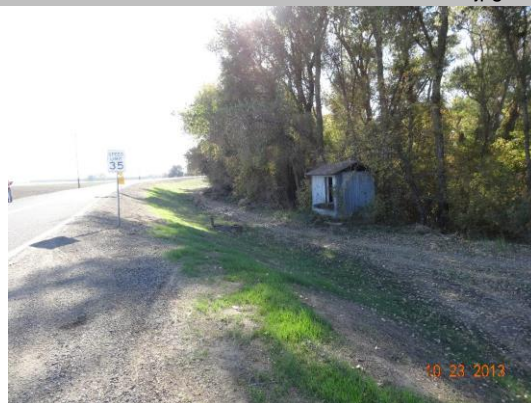
Photo 2 of 3 : UCIP_SP_2018_24191_42678.jpg

View of waterward side--only pump house of nearby crossing located downstream from crossing.

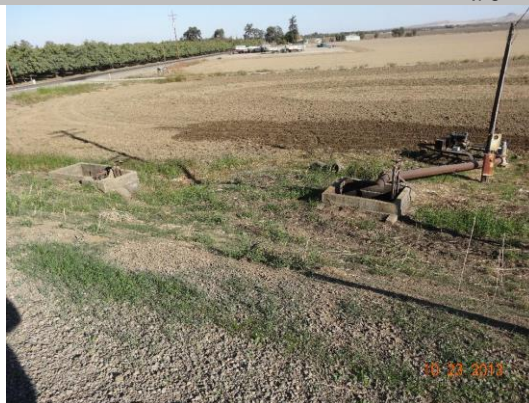
Photo 3 of 3 : UCIP_SP_2018_24191_42676.jpg

Comment Code						
Inspector Comment						
FS_ID:24191 DS_ID:21389 EP_NO: 1264 Repair Type: Non-Urgent Crossing Status: Indicator Found UCIP Comments: Need to coordinate with owner to determine status of crossing. If crossing is no longer in use owner will need to contact the CVFPB to comply with Title 23. This crossing is referenced in the USACE Periodic Inspection as item USACE_CESPK_MRD2_2012_p_0124. FIELD_STRUCT_DESC: *ABANDONED* 10-inch (not 14-inch as specified in the permit) irrigation discharge pipe of an unknown material through the levee, 5 feet below the crown. Pump on the waterside (WS). Double concrete discharge box at the landside (LS) toe. (Plans for installing an irrigation pumping plant and a 14-inch steel discharge pipe through the levee authorized under Permit No. 1264, 1948 - Robert Chesney). [Additional Reference(s): DWR Levee Log, 2007]. FS Date: 10/23/2013

View of landward side--two crossing nearby.

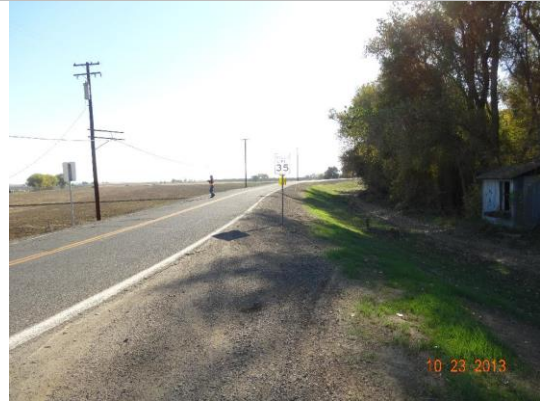
Photo 1 of 3 : UCIP_SP_2018_24190_42667.jpg

FS_ID:24190
DS_ID:21388
EP_NO: 10008
Repair Type: Non-Urgent
Crossing Status: Found
UCIP Comments: Concrete distribution box is damage on waterward side. Need to contact owner to determine status of crossing. If crossing is no longer in use owner will need to coordinate with DWR inspector and CVFPB to remove according to Title 23 requirements. This crossing is referenced in the USACE Periodic Inspection as item USACE_CESPK_MRD2_2012_p_0380.
FIELD_STRUCT_DESC: *ABANDONED* 18-inch steel irrigation discharge pipe through the levee, 15 feet below the crown. Pump in a pump house on the waterside (WS). Slide gate on the WS. Concrete distribution box on the landside (LS). During field verification, additional appurtenances were observed. An additional pipe on the LS drains into the concrete distribution box. The concrete distribution box connects to a second set of distribution boxes through a 24-inch reinforced concrete pipe approximately 36 feet upstream of the crossing. Those boxes have a 10-inch pipe which appears to go through the levee. (Retention of an 18-inch corrugated metal pipe (CMP) through the levee, 15 feet below the crown, a pump, a slide gate, and a concrete distribution box authorized under Automatic Board Order (ABO) issued as Permit No. 10008, 1974 - Frances C. Yates). [Additional Reference(s): DWR Levee Log, 2007. USACE Sacramento O&M Manual 134, June 1953, (Station 694+85)].

View of levee crown at crossing.

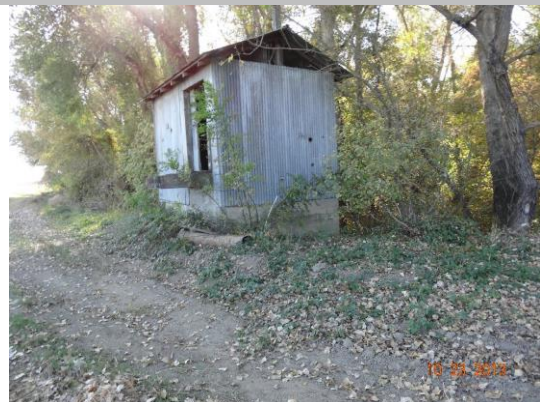
Photo 2 of 3 : UCIP_SP_2018_24190_42668.jpg

Pump house located on waterward side.

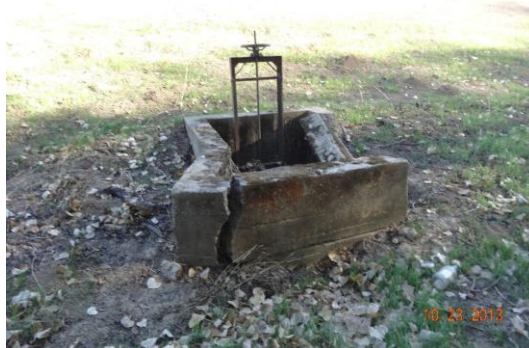
Photo 3 of 3 : UCIP_SP_2018_24190_42669.jpg

FS_ID:24190
DS_ID:21388
EP_NO: 10008
Repair Type: Non-Urgent
Crossing Status: Found
UCIP Comments: Concrete distribution box is damage on waterward side. Need to contact owner to determine status of crossing. If crossing is no longer in use owner will need to coordinate with DWR inspector and CVFPB to remove according to Title 23 requirements. This crossing is referenced in the USACE Periodic Inspection as item USACE_CESPK_MRD2_2012_p_0380.
FIELD_STRUCT_DESC: *ABANDONED* 18-inch steel irrigation discharge pipe through the levee, 15 feet below the crown. Pump in a pump house on the waterside (WS). Slide gate on the WS. Concrete distribution box on the landside (LS). During field verification, additional appurtenances were observed. An additional pipe on the LS drains into the concrete distribution box. The concrete distribution box connects to a second set of distribution boxes through a 24-inch reinforced concrete pipe approximately 36 feet upstream of the crossing. Those boxes have a 10-inch pipe which appears to go through the levee. (Retention of an 18-inch corrugated metal pipe (CMP) through the levee, 15 feet below the crown, a pump, a slide gate, and a concrete distribution box authorized under Automatic Board Order (ABO) issued as Permit No. 10008, 1974 - Frances C. Yates). [Additional Reference(s): DWR Levee Log, 2007. USACE Sacramento O&M Manual 134, June 1953, (Station 694+85)].

Damage concrete distribution box located on waterward side.

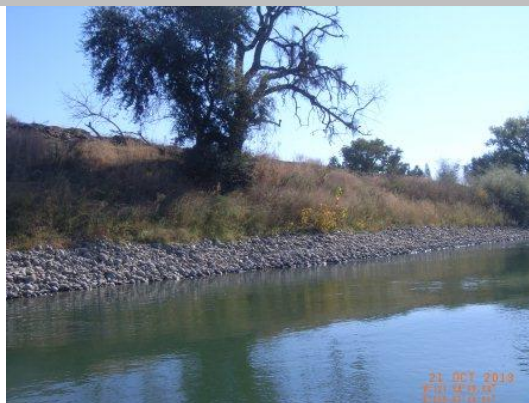
Photo 1 of 1 : SP_2018_RD0070_30_2_20180305_00002.jpg

LM Start	8.10	Rating **	M	Issue No.	2
LM End	8.23	Issue Type +	Ma	Location *	WS
Category	Supplemental			GPS Latitude/Longitude	
				Start	End
Item	2015 USACE Erosion Survey, DRAFT			39.122459 °	39.120684 °
				-121.910121 °	-121.909152 °
DWR ID	DWR_RD0070_02_s_2016_2				
Comment Code					
Inspector Comment					
1997 - Critical Site - Erosion of cobble site on outside of a bend. Failure caused by erosion of a material from behind the cobbles and cobbles rolling down the slope. Failure is just above the toe levee. Some repairs had been done at the upstream end. 2004 - Some minor new erosion at the top of the berm. 2005 - Trees look okay and the downstream end has some new rock repair. Site is no longer critical. 2006 - No longer critical, some repairs. 2015: No observed changes. [2015 Site ID: SAC_130-0_L]

USACE 2013 Photo #1

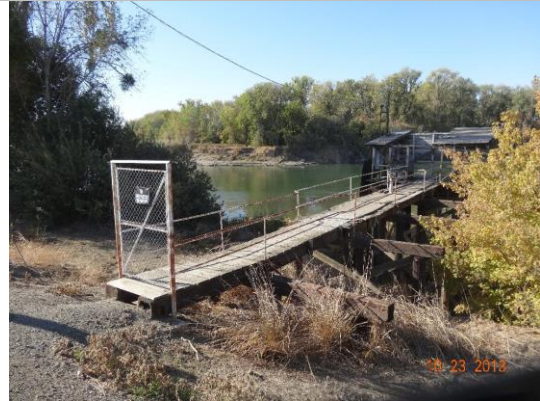
Photo 1 of 3 : UCIP_SP_2018_24108_42463.jpg

FS_ID:24108
DS_ID:21423
EP_NO: 9971
Repair Type: Non-Urgent
Crossing Status: Found
UCIP Comments: Will need to contact owner. Need to obtain maintenance records and clarify modifications made to crossing (size). This crossing is referenced in the USACE Periodic Inspection as item USACE_CESPK_MRD2_2012_p_0433.
FIELD_STRUCT_DESC: [Meridian Farms Water Company Pumping Plant No. 3] 2 of 3: 16-inch irrigation discharge pipe of an unknown material (not a 30-inch pipe, as mentioned in the desk study) through the levee, 20.5 feet below the crown. Gate valve on the waterside (WS) end. Pump on a pile structure in the stream. Wooden walkway to the pump. Concrete distribution box on the landside (LS). (Retention of a 30-inch steel pipe through the levee, 20.5 feet below the crown, a pump, a gate valve, and a concrete distribution box authorized under Automatic Board Order (ABO) issued as Permit No. 9971, 1974 - Georgia Chesney, Life Estate. Plans to demolish and remove the existing Meridian Diversion Pumping Facility and the existing Drexler Diversion Pumping Facility and to construct a new Meridian Diversion Pumping Facility with two retractable fish screens and a 72-inch gravity feed intake pipe under the levee authorized under Permit No. 18762, 2013 - Meridian Farms Water Company). [Additional Reference(s): DWR Levee Log, 2007].

View of landward side--pump station and walkway

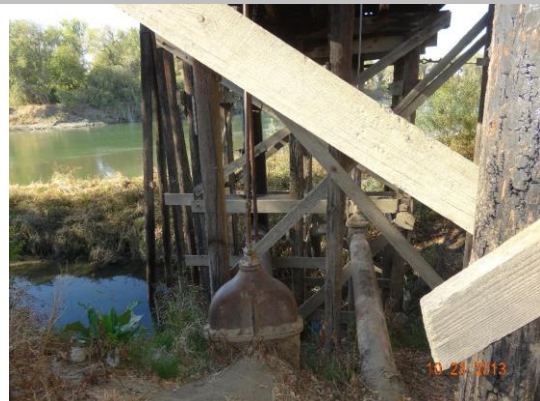
Photo 2 of 3 : UCIP_SP_2018_24108_42465.jpg

View of 16-inch pipe and 24-inch pipe with screw gate located on waterward side.

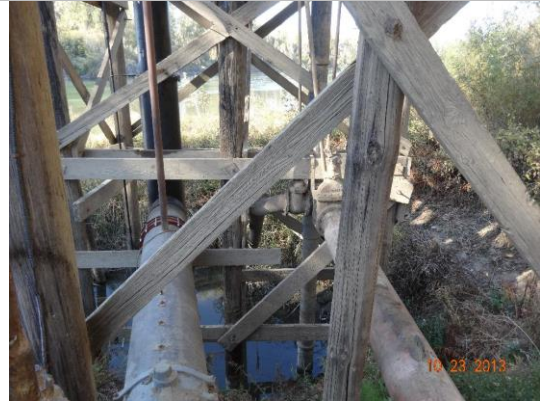
Photo 3 of 3 : UCIP_SP_2018_24108_42464.jpg

FS_ID:24108
DS_ID:21423
EP_NO: 9971
Repair Type: Non-Urgent
Crossing Status: Found
UCIP Comments: Will need to contact owner. Need to obtain maintenance records and clarify modifications made to crossing (size). This crossing is referenced in the USACE Periodic Inspection as item USACE_CESPK_MRD2_2012_p_0433.
FIELD_STRUCT_DESC: [Meridian Farms Water Company Pumping Plant No. 3] 2 of 3: 16-inch irrigation discharge pipe of an unknown material (not a 30-inch pipe, as mentioned in the desk study) through the levee, 20.5 feet below the crown. Gate valve on the waterside (WS) end. Pump on a pile structure in the stream. Wooden walkway to the pump. Concrete distribution box on the landside (LS). (Retention of a 30-inch steel pipe through the levee, 20.5 feet below the crown, a pump, a gate valve, and a concrete distribution box authorized under Automatic Board Order (ABO) issued as Permit No. 9971, 1974 - Georgia Chesney, Life Estate. Plans to demolish and remove the existing Meridian Diversion Pumping Facility and the existing Drexler Diversion Pumping Facility and to construct a new Meridian Diversion Pumping Facility with two retractable fish screens and a 72-inch gravity feed intake pipe under the levee authorized under Permit No. 18762, 2013 - Meridian Farms Water Company). [Additional Reference(s): DWR Levee Log, 2007].

View of 16-inch pipe and 24-inch pipe located on waterward side.

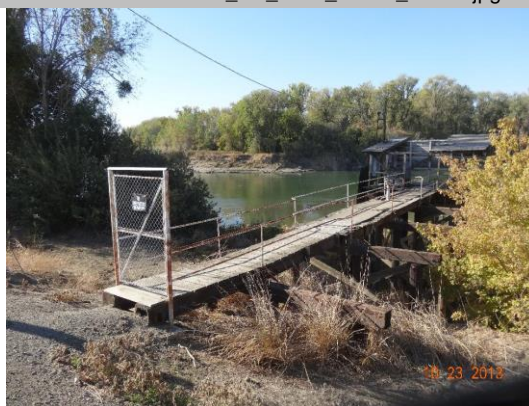
Photo 1 of 3 : UCIP_SP_2018_24107_42457.jpg

Comment Code						
Inspector Comment						
FS_ID:24107 DS_ID:21394 EP_NO: N/A Repair Type: Non-Urgent Crossing Status: Found UCIP Comments: This pump station is to be demolished. This crossing will need to be updated once the work has been completed. This crossing is referenced in the USACE Periodic Inspection as item USACE_CESPK_MRD2_2012_p_0433. FIELD_STRUCT_DESC: [Meridian Farms Water Company Pumping Plant No. 3] 3 of 3: 24-inch irrigation discharge pipe of an unknown material through the levee, 20.5 feet below the crown. Gate valve on the waterside (WS) end. Pump on a pile structure in the stream. Wooden walkway to the pump. Concrete distribution box on the landside (LS). (Plans to demolish and remove the existing Meridian Diversion Pumping Facility and the existing Drexler Diversion Pumping Facility and to construct a new Meridian Diversion Pumping Facility with two retractable fish screens and a 72-inch gravity feed intake pipe under the levee authorized under Permit No. 18762, 2013 - Meridian Farms Water Company). [Additional Reference(s): DWR Levee Log, 2007]. FS Date: 10/23/2013

View of waterward side--pump station and walkway.

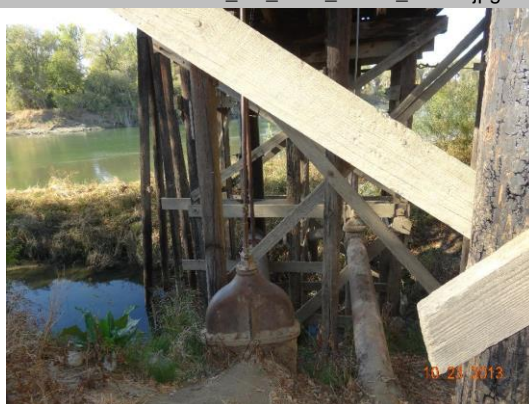
Photo 2 of 3 : UCIP_SP_2018_24107_42458.jpg

View of 16-inch pipe and 24-inch pipe through levee on waterward side.

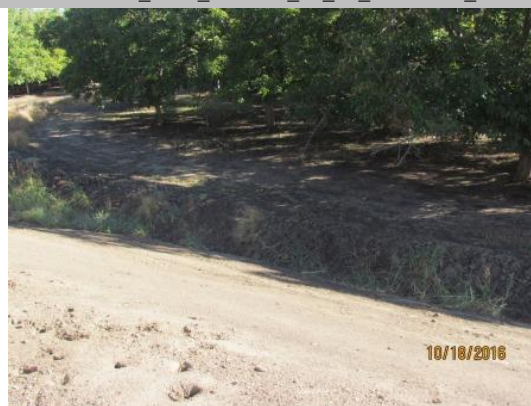
Photo 1 of 1 : SP_2018_RD0070_30_62_20180305_00011.jpg

LM Start	9.57	Rating **	U	Issue No.	62
LM End	9.70	Issue Type +	En	Location *	LS
Category	Earthen Levee			GPS Latitude/Longitude	
				Start	End
Item	Encroachments			39.103192 °	39.101213 °
				-121.899606 °	-121.899380 °
DWR ID	DWR_RD0070_02_f_2016_62				
Comment Code					
DT : Ditch					
Inspector Comment

View of a ditch along the landside toe.

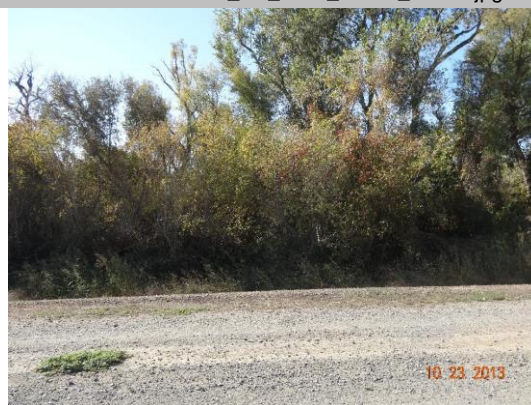
Photo 1 of 3 : UCIP_SP_2018_23967_42129.jpg

Comment Code					
Inspector Comment					
FS_ID:23967 DS_ID:21396 EP_NO: N/A Repair Type: Non-Urgent Crossing Status: Indicator Found UCIP Comments: No evidence of pipe is visible on waterward side. Need to coordinate with owner to determine status of crossing. If crossing is no longer in use owner will need to contact the CVFPB to comply with Title 23. This crossing is referenced in the USACE Periodic Inspection as item USACE_CESPK_MRD2_2012_p_0477. FIELD_STRUCT_DESC: *ABANDONED* 12-inch pipe of an unknown material or purpose through the levee, 3.1 feet below the crown. Siphon breaker in a corrugated metal pipe (CMP) riser on the landside (LS) shoulder. Concrete plug on the LS end. Wooden distribution box on the LS at the discharge end. (Cat. IV-A). [Additional Reference(s): DWR Levee Log, 2007. USACE Sacramento O&M Manual 134, June 1953, (Station 813+00)]. FS Date: 10/23/2013

View of waterward side.

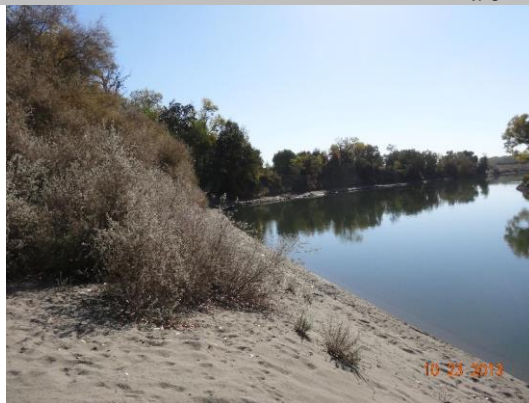
Photo 2 of 3 : UCIP_SP_2018_23967_42132.jpg

Comment Code					
Inspector Comment					
FS_ID:23967 DS_ID:21396 EP_NO: N/A Repair Type: Non-Urgent Crossing Status: Indicator Found UCIP Comments: No evidence of pipe is visible on waterward side. Need to coordinate with owner to determine status of crossing. If crossing is no longer in use owner will need to contact the CVFPB to comply with Title 23. This crossing is referenced in the USACE Periodic Inspection as item USACE_CESPK_MRD2_2012_p_0477. FIELD_STRUCT_DESC: *ABANDONED* 12-inch pipe of an unknown material or purpose through the levee, 3.1 feet below the crown. Siphon breaker in a corrugated metal pipe (CMP) riser on the landside (LS) shoulder. Concrete plug on the LS end. Wooden distribution box on the LS at the discharge end. (Cat. IV-A). [Additional Reference(s): DWR Levee Log, 2007. USACE Sacramento O&M Manual 134, June 1953, (Station 813+00)]. FS Date: 10/23/2013

No pipe exists levee on waterward side only CMP riser present on landward side.

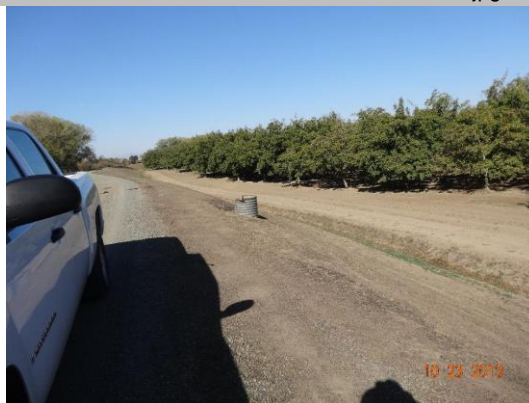
Photo 3 of 3 : UCIP_SP_2018_23967_42131.jpg

CMP riser located on landward shoulder.

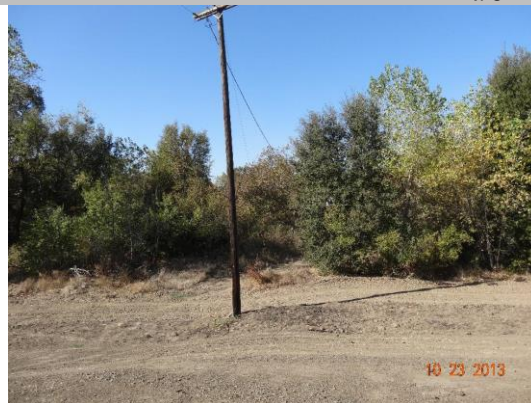
Photo 1 of 3 : UCIP_SP_2018_24195_42686.jpg

FS_ID:24195
DS_ID:21398
EP_NO: 1162
Repair Type: Non-Urgent
Crossing Status: Found
UCIP Comments: Need to verify status of crossing--variation in pipe size. 18 inch pipe listed in desk study and 20 inch pipe found in field. Damage to siphon breaker housing unit. This crossing is referenced in the USACE Periodic Inspection as item USACE_CESPK_MRD2_2012_p_0482.
FIELD_STRUCT_DESC: 1 of 2: 20-inch steel irrigation discharge pipe (not 18-inch, as referenced in the permit) through the levee, 3.7 feet below the crown. Concrete cutoff wall around the pipe at each shoulder. Siphon breaker in a steel pipe riser on the landside (LS) shoulder. Slant pump on a wooden pump structure on the waterside (WS). Corrugated metal pipe (CMP) riser under the pump structure at the WS toe. Distribution box at the LS toe. (Plans for the installation of two 18-inch steel discharge pipes through the levee and a pumping plant in the river authorized under Permit No. 1162, 1946 - Homer and Arthur Andreotti). [Additional Reference(s): DWR Levee Log, 2007. USACE Sacramento O&M Manual 134, June 1953, (Station 824+00)].

View of waterward side pathway behind power pole leads to pump station.

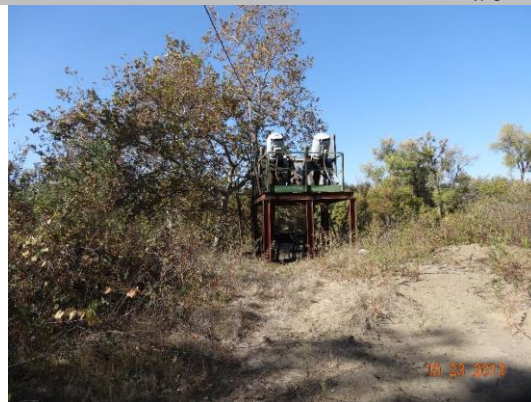
Photo 2 of 3 : UCIP_SP_2018_24195_42685.jpg

Pump station located on waterward side.

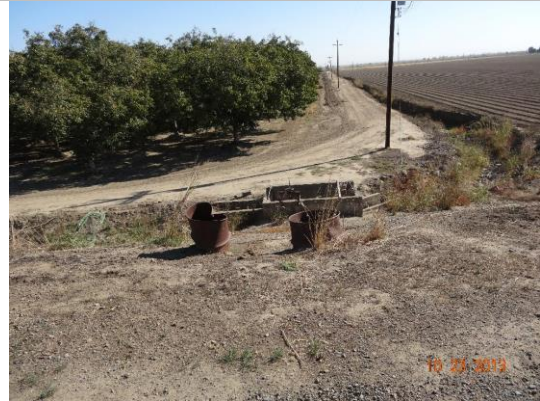
Photo 3 of 3 : UCIP_SP_2018_24195_42688.jpg

Item	DWR UCIP Field Study			39.093712 °	39.093712 °	
				-121.892553 °	-121.892553 °	
DWR ID						
Comment Code						
Inspector Comment						
FS_ID:24195 DS_ID:21398 EP_NO: 1162 Repair Type: Non-Urgent Crossing Status: Found UCIP Comments: Need to verify status of crossing--variation in pipe size. 18 inch pipe listed in desk study and 20 inch pipe found in field. Damage to siphon breaker housing unit. This crossing is referenced in the USACE Periodic Inspection as item USACE_CESPK_MRD2_2012_p_0482. FIELD_STRUCT_DESC: 1 of 2: 20-inch steel irrigation discharge pipe (not 18-inch, as referenced in the permit) through the levee, 3.7 feet below the crown. Concrete cutoff wall around the pipe at each shoulder. Siphon breaker in a steel pipe riser on the landside (LS) shoulder. Slant pump on a wooden pump structure on the waterside (WS). Corrugated metal pipe (CMP) riser under the pump structure at the WS toe. Distribution box at the LS toe. (Plans for the installation of two 18-inch steel discharge pipes through the levee and a pumping plant in the river authorized under Permit No. 1162, 1946 - Homer and Arthur Andreotti). [Additional Reference(s): DWR Levee Log, 2007. USACE Sacramento O&M Manual 134, June 1953, (Station 824+00)]. FS Date: 10/23/2013

View of landward side.

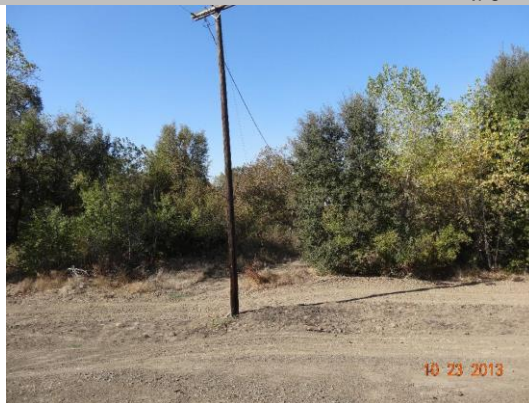
Photo 1 of 3 : UCIP_SP_2018_24196_42693.jpg

Comment Code						
Inspector Comment						
FS_ID:24196 DS_ID:21430 EP_NO: 1162 Repair Type: Non-Urgent Crossing Status: Found UCIP Comments: Need to verify status of crossing--variation in pipe size. 18 inch pipe listed in desk study and 20 inch pipe found in field. This crossing is referenced in the USACE Periodic Inspection as item USACE_CESPK_MRD2_2012_p_0482. FIELD_STRUCT_DESC: 2 of 2: 20-inch steel irrigation discharge pipe (not 18-inch, as referenced in the permit) through the levee, 3.7 feet below the crown. Concrete cutoff wall around the pipe at each shoulder. Siphon breaker in a steel pipe riser on the landside (LS) shoulder. Slant pump on a wooden pump structure on the waterside (WS). Corrugated metal pipe (CMP) riser under the pump structure at the WS toe. Distribution box at the LS toe. (Plans for the installation of two 18-inch steel discharge pipes through the levee and a pumping plant in the river authorized under Permit No. 1162, 1946 - Homer and Arthur Andreotti). [Additional Reference(s): DWR Levee Log, 2007. USACE Sacramento O&M Manual 134, June 1953, (Station 824+00)]. FS Date: 10/23/2013

View of waterward side path to pump station is behind the power pole.

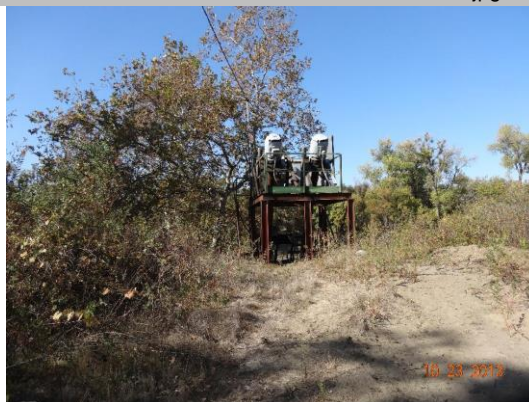
Photo 2 of 3 : UCIP_SP_2018_24196_42692.jpg

Pump station on waterward side dense vegetation on slope.

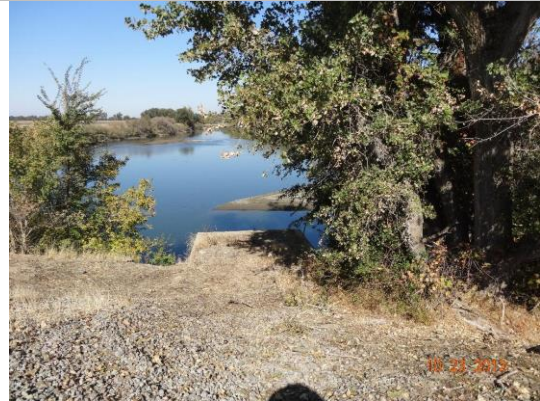
Photo 1 of 3 : UCIP_SP_2018_24197_42699.jpg

Comment Code					
Inspector Comment					
FS_ID:24197 DS_ID:21400 EP_NO: 9986 Repair Type: Non-Urgent Crossing Status: Indicator Found UCIP Comments: Need to coordinate with owner to determine status of crossing. If crossing is no longer in use owner will need to contact the CVFPB to comply with Title 23. This crossing is referenced in the USACE Periodic Inspection as item USACE_CESPK_MRD2_2012_p_0527. FIELD_STRUCT_DESC: *ABANDONED* 30-inch steel irrigation discharge pipe through the levee, 27.5 feet below the crown. Two electric gate valves in a concrete pit on the waterside (WS) end, at the end of the discharge pipe. Two slant pumps on the WS slope. Control switches in a corrugated metal shed at the WS shoulder. (Plans for the installation of two inclined turbine pumps, a gate valve, a 50-horsepower pump, and an electrical conduit authorized under Permit No. 5193, 1965 - Meridian Farms Water Company. Retention of a 30-inch steel pipe through the levee, 27.5 feet below the crown, two gate valves, two slant pumps, and a metal building with switch panels authorized under Automatic Board Order (ABO) issued as Permit No. 9986, 1974 - Meridian Farms Water Company. Plans to abolish existing pumping plant and to abandon existing pipeline at RM 125.8 and to construct a new pumping plant at RM 127.0 consisting of two 30-inch intake pipes supported by seven 10-inch by 10-inch H beams, a fish screen, and a 36-inch pipe trenched through the levee, and to place riprap on the slope authorized under Permit No. 18323, 2009 - Meridian Farms Water Company). [Additional Reference(s): DWR Levee Log, 2007. USACE Sacramento O&M Manual 134, June 1953, (Station 889+72)]. FS Date: 10/23/2013

View of waterward side.

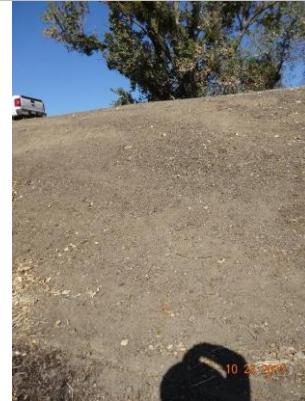
Photo 2 of 3 : UCIP_SP_2018_24197_42698.jpg

FS_ID:24197
 DS_ID:21400
 EP_NO: 9986
 Repair Type: Non-Urgent
 Crossing Status: Indicator Found
 UCIP Comments: Need to coordinate with owner to determine status of crossing. If crossing is no longer in use owner will need to contact the CVFPB to comply with Title 23. This crossing is referenced in the USACE Periodic Inspection as item USACE_CESPK_MRD2_2012_p_0527.
 FIELD_STRUCT_DESC: *ABANDONED* 30-inch steel irrigation discharge pipe through the levee, 27.5 feet below the crown. Two electric gate valves in a concrete pit on the waterside (WS) end, at the end of the discharge pipe. Two slant pumps on the WS slope. Control switches in a corrugated metal shed at the WS shoulder. (Plans for the installation of two inclined turbine pumps, a gate valve, a 50-horsepower pump, and an electrical conduit authorized under Permit No. 5193, 1965 - Meridian Farms Water Company. Retention of a 30-inch steel pipe through the levee, 27.5 feet below the crown, two gate valves, two slant pumps, and a metal building with switch panels authorized under Automatic Board Order (ABO) issued as Permit No. 9986, 1974 - Meridian Farms Water Company. Plans to abolish existing pumping plant and to abandon existing pipeline at RM 125.8 and to construct a new pumping plant at RM 127.0 consisting of two 30-inch intake pipes supported by seven 10-inch by 10-inch H beams, a fish screen, and a 36-inch pipe trenched through the levee, and to place riprap on the slope authorized under Permit No. 18323, 2009 - Meridian Farms Water Company). [Additional Reference(s): DWR Levee Log, 2007. USACE Sacramento O&M Manual 134, June 1953, (Station 889+72)].

View of landward slope.

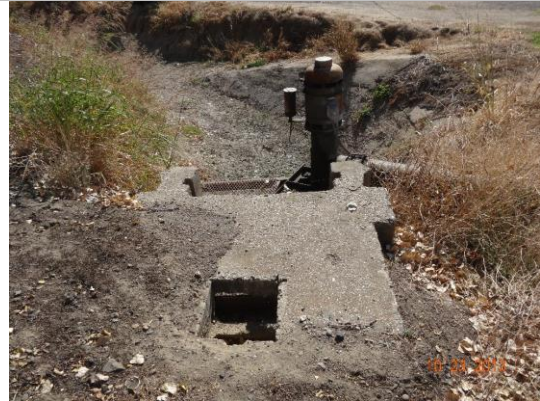
Photo 3 of 3 : UCIP_SP_2018_24197_42697.jpg

FS_ID:24197
DS_ID:21400
EP_NO: 9986
Repair Type: Non-Urgent
Crossing Status: Indicator Found
UCIP Comments: Need to coordinate with owner to determine status of crossing. If crossing is no longer in use owner will need to contact the CVFPB to comply with Title 23. This crossing is referenced in the USACE Periodic Inspection as item USACE_CESPK_MRD2_2012_p_0527.
FIELD_STRUCT_DESC: *ABANDONED* 30-inch steel irrigation discharge pipe through the levee, 27.5 feet below the crown. Two electric gate valves in a concrete pit on the waterside (WS) end, at the end of the discharge pipe. Two slant pumps on the WS slope. Control switches in a corrugated metal shed at the WS shoulder. (Plans for the installation of two inclined turbine pumps, a gate valve, a 50-horsepower pump, and an electrical conduit authorized under Permit No. 5193, 1965 - Meridian Farms Water Company. Retention of a 30-inch steel pipe through the levee, 27.5 feet below the crown, two gate valves, two slant pumps, and a metal building with switch panels authorized under Automatic Board Order (ABO) issued as Permit No. 9986, 1974 - Meridian Farms Water Company. Plans to abolish existing pumping plant and to abandon existing pipeline at RM 125.8 and to construct a new pumping plant at RM 127.0 consisting of two 30-inch intake pipes supported by seven 10-inch by 10-inch H beams, a fish screen, and a 36-inch pipe trenched through the levee, and to place riprap on the slope authorized under Permit No. 18323, 2009 - Meridian Farms Water Company). [Additional Reference(s): DWR Levee Log, 2007. USACE Sacramento O&M Manual 134, June 1953, (Station 889+72)].

View of concrete slab with pump located on landward side.

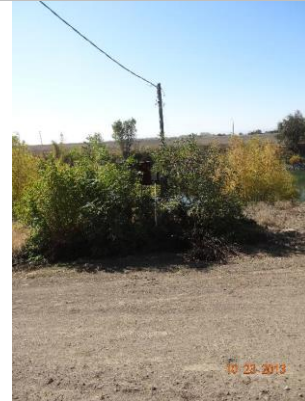
Photo 1 of 3 : UCIP_SP_2018_47033_42141.jpg

Comment Code						
Inspector Comment						
FS_ID:47033 DS_ID:21402 EP_NO: 9997 Repair Type: Non-Urgent Crossing Status: Found UCIP Comments: Debris found on waterward side along berm running parallel to levee. Two crossing found--Need to coordinate with owner to determine permit for second crossing and status of crossing. If crossing is no longer in use owner will need to contact the CVFPB to comply with Title 23. Dense vegetation limits the inspector's visibility to identify signs of pipe failure (leaks) along the waterward slope. Recommend removing vegetation along pipe alignment to conduct proper inspection of structure and appurtenances. This crossing is referenced in the USACE Periodic Inspection as item USACE_CESPK_MRD2_2012_p_0559. FIELD_STRUCT_DESC: 12-inch steel irrigation discharge pipe through the levee, 3.5 feet below the crown. Siphon breaker in a corrugated metal pipe (CMP) riser on the landside (LS) shoulder. Pump and control valve on the waterside (WS). Power pole on the WS shoulder. Discharge box at the LS toe. (Retention of a 12-inch steel pipe through the levee, 3.5 feet below the crown, a pump, a control valve, a siphon breaker, and a discharge box authorized under Automatic Board Order (ABO) issued as Permit No. 9997, 1974 - H. and Anne M. Rohleder). [Additional Reference(s): DWR Levee Log, 2007. USACE Sacramento O&M Manual 134, June 1953, (Station 930+22)]. FS Date: 10/23/2013

Crossing appurtenances located near brush and power pole on waterward side.

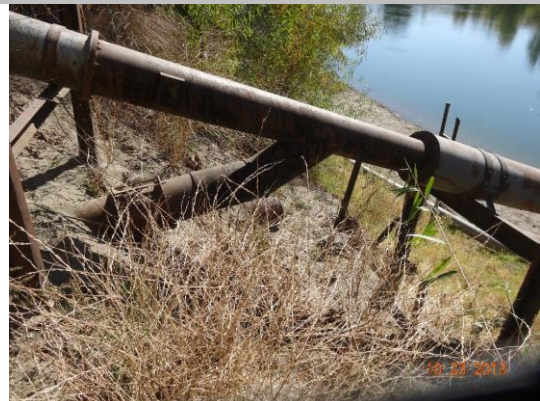
Photo 2 of 3 : UCIP_SP_2018_47033_42139.jpg

Pipe crossing on waterward side. Second pipe comes out approximately 3 feet downstream from this crossing.

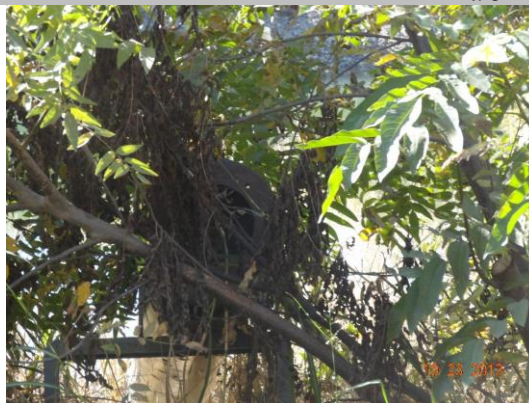
Photo 3 of 3 : UCIP_SP_2018_47033_42143.jpg

Item	DWR UCIP Field Study			39.072540 °		39.072540 °
				-121.887807 °		-121.887807 °
DWR ID						
Comment Code						
Inspector Comment						
FS_ID:47033 DS_ID:21402 EP_NO: 9997 Repair Type: Non-Urgent Crossing Status: Found UCIP Comments: Debris found on waterward side along berm running parallel to levee. Two crossing found--Need to coordinate with owner to determine permit for second crossing and status of crossing. If crossing is no longer in use owner will need to contact the CVFPB to comply with Title 23. Dense vegetation limits the inspector's visibility to identify signs of pipe failure (leaks) along the waterward slope. Recommend removing vegetation along pipe alignment to conduct proper inspection of structure and appurtenances. This crossing is referenced in the USACE Periodic Inspection as item USACE_CESPK_MRD2_2012_p_0559. FIELD_STRUCT_DESC: 12-inch steel irrigation discharge pipe through the levee, 3.5 feet below the crown. Siphon breaker in a corrugated metal pipe (CMP) riser on the landside (LS) shoulder. Pump and control valve on the waterside (WS). Power pole on the WS shoulder. Discharge box at the LS toe. (Retention of a 12-inch steel pipe through the levee, 3.5 feet below the crown, a pump, a control valve, a siphon breaker, and a discharge box authorized under Automatic Board Order (ABO) issued as Permit No. 9997, 1974 - H. and Anne M. Rohleder). [Additional Reference(s): DWR Levee Log, 2007. USACE Sacramento O&M Manual 134, June 1953, (Station 930+22)]. FS Date: 10/23/2013

Pipe section exposed unable to determine if it is still in use.

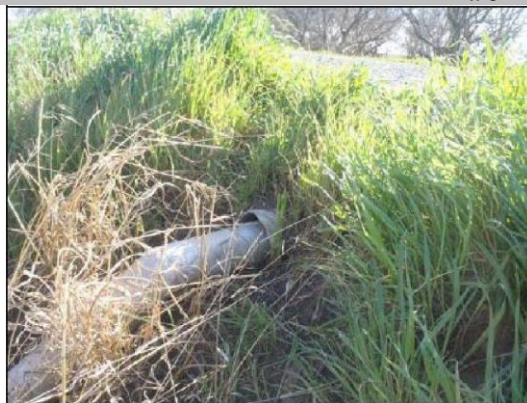
Photo 1 of 3 : UCIP_SP_2018_50086_42883.jpg

FS_ID:50086
DS_ID:24744
EP_NO: N/A
Repair Type: Non-Urgent
Crossing Status: Found
UCIP Comments: 07/07/2016 Dense vegetation on both slopes. No damage was observed on levee slopes or crown, crossing was downgraded from Urgent to Non-Urgent. No permit found for crossing. Need to recheck during winter. According to Andy Duffey, District Representative, CVFPB has issued a enforcement letter to owner dated 6/23/2016. (DWR UCIP - omagana)10/23/2013 No records were found during initial desk study--need to contact owner to obtain permit number authorizing work. Owner will need to coordinate with DWR Inspector and CVFPB to remove crossing according to Title 23 requirements. (DWR UCIP - omagana)
FIELD_STRUCT_DESC: 6-inch aluminum irrigation pipe sleeved through a 10-inch corrugated metal pipe through the levee, 1.5 feet below the crown. Annular space not grouted. Pipe extends down both slopes about 2 feet below the crown.

View of pipe through levee--photo is from USACE PI Draft Report dated 6-2012.

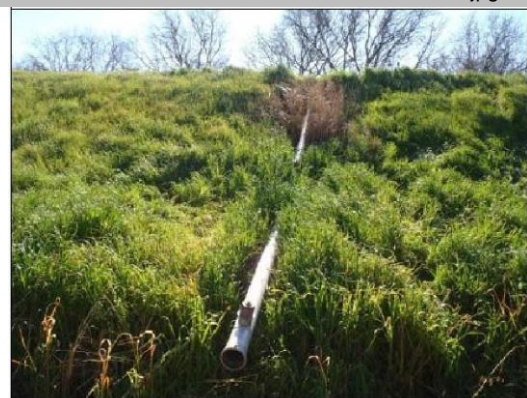
Photo 2 of 3 : UCIP_SP_2018_50086_42882.jpg

View of pipe through levee--photo is from USACE PI Draft Report dated 6-2012.

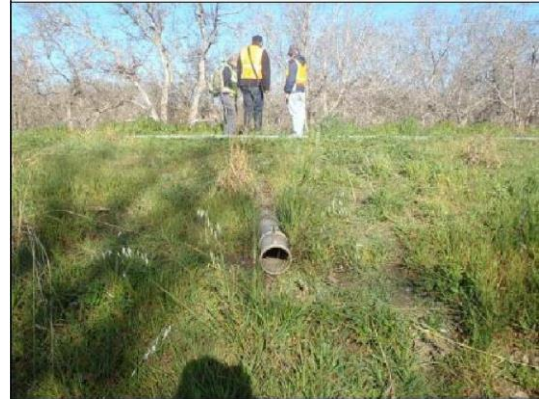
Photo 3 of 3 : UCIP_SP_2018_50086_42881.jpg

Item	DWR UCIP Field Study			39.072480 °	39.072480 °	
				-121.886540 °	-121.886540 °	
DWR ID						
Comment Code						
Inspector Comment						
FS_ID:50086 DS_ID:24744 EP_NO: N/A Repair Type: Non-Urgent Crossing Status: Found UCIP Comments: 07/07/2016 Dense vegetation on both slopes. No damage was observed on levee slopes or crown, crossing was downgraded from Urgent to Non-Urgent. No permit found for crossing. Need to recheck during winter. According to Andy Duffey, District Representative, CVFPB has issued a enforcement letter to owner dated 6/23/2016. (DWR UCIP - omagana)10/23/2013 No records were found during initial desk study--need to contact owner to obtain permit number authorizing work. Owner will need to coordinate with DWR Inspector and CVFPB to remove crossing according to Title 23 requirements. (DWR UCIP - omagana) FIELD_STRUCT_DESC: 6-inch aluminum irrigation pipe sleeved through a 10-inch corrugated metal pipe through the levee, 1.5 feet below the crown. Annular space not grouted. Pipe extends down both slopes about 2 feet below the crown. FS Date: 7/7/2016 10:39:00 AM

View of pipe through levee--photo is from USACE PI Draft Report dated 6-2012.

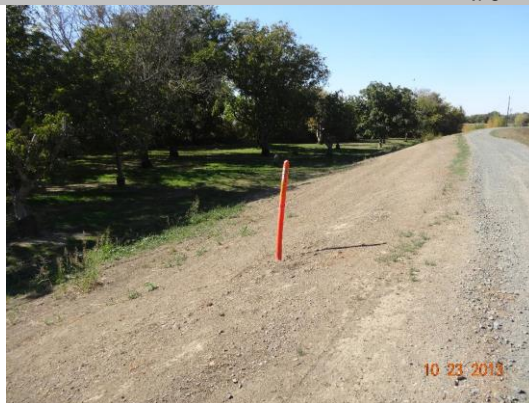
Photo 1 of 3 : UCIP_SP_2018_23984_42172.jpg

FS_ID:23984
DS_ID:21403
EP_NO: 3800
Repair Type: Non-Urgent
Crossing Status: Indicator Found
UCIP Comments: Need to contact owner to determine if crossing is still active and to determine last inspection date. Will need copy of letter showing crossings passed inspection. This crossing is referenced in the USACE Periodic Inspection as item USACE_CESPK_MRD2_2012_p_0568.
FIELD_STRUCT_DESC: 20-inch coated steel natural gas pipeline through the levee, 3 feet below the crown. Concrete cutoff wall around the pipe at the center of the levee. Marker sign on the waterside (WS) shoulder. Natural gas equipment pad at the landside (LS) toe. (Plans to construct and maintain a 20-inch gas line across the Sacramento River authorized under Permit No. 3800, 1961 - Pacific Gas and Electric Company [PG&E]). [Additional Reference(s): DWR Levee Log, 2007].
FS Date: 10/23/2013

Marker located on waterward side.

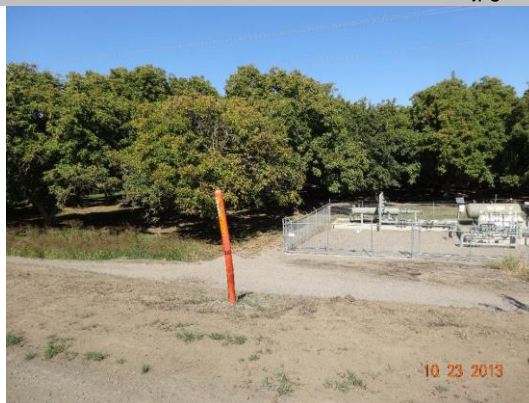
Photo 2 of 3 : UCIP_SP_2018_23984_42171.jpg

Marker on landward side.

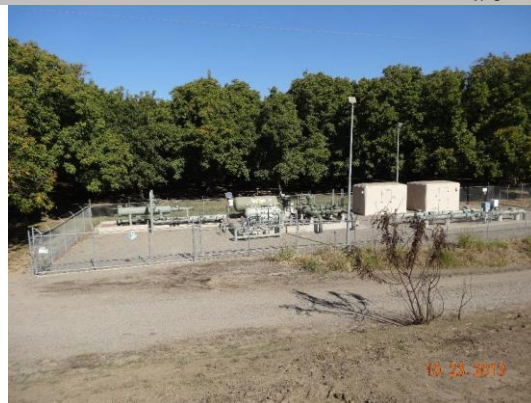
Photo 3 of 3 : UCIP_SP_2018_23984_42170.jpg

Item	DWR UCIP Field Study			39.072512 °		39.072512 °
				-121.886000 °		-121.886000 °
DWR ID						
Comment Code						
Inspector Comment						
FS_ID:23984 DS_ID:21403 EP_NO: 3800 Repair Type: Non-Urgent Crossing Status: Indicator Found UCIP Comments: Need to contact owner to determine if crossing is still active and to determine last inspection date. Will need copy of letter showing crossings passed inspection. This crossing is referenced in the USACE Periodic Inspection as item USACE_CESPK_MRD2_2012_p_0568. FIELD_STRUCT_DESC: 20-inch coated steel natural gas pipeline through the levee, 3 feet below the crown. Concrete cutoff wall around the pipe at the center of the levee. Marker sign on the waterside (WS) shoulder. Natural gas equipment pad at the landside (LS) toe. (Plans to construct and maintain a 20-inch gas line across the Sacramento River authorized under Permit No. 3800, 1961 - Pacific Gas and Electric Company [PG&E]). [Additional Reference(s): DWR Levee Log, 2007]. FS Date: 10/23/2013

Additional appurtenances located on landward side.

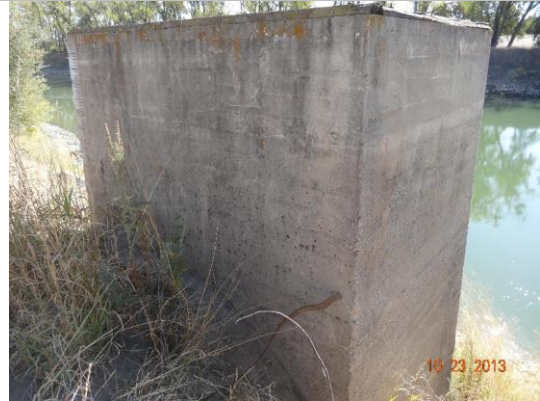
Photo 1 of 1 : UCIP_SP_2018_47039_42800.jpg

FS_ID:47039
DS_ID:21407
EP_NO: 9995
Repair Type: Non-Urgent
Crossing Status: Indicator Found
UCIP Comments: Records show a 24-inch iron pipe through the waterward side along the old gaging station with the concrete struture located on the waterward slope.
FIELD_STRUCT_DESC: [Reclamation District No. 70 (RD0070) Drainage Plant] 1 of 5: 30-inch steel drainage discharge pipe through the levee at low elevation. Pipe is concrete encased under the crown, between the shoulders. Slide gate on the landside (LS). Flap gate in a secured structure on the waterside (WS) end. (Retention of a 30-inch steel drainage pipe through the levee, at low elevation, a slide gate, and a flap gate authorized under Automatic Board Order (ABO) issued as Permit No. 9995, 1974 - RD0070. Plans to construct a 10-foot by 12-foot by 19-foot concrete outlet structure on existing outlet pipes, to repair leaking pipes, to repair existing pumping plant, and to install sheet piling at the inlet ditch to allow continued operation of the pumping plant by the district authorized under Permit No. 13420, 1982 - RD0070). [Additional Reference(s): DWR Levee Log, 2007. USACE Sacramento O&M Manual 134, June 1953, (Station 1007+10), referenced pipes at this location are 48 inches, 40 inches, and 50 inches].

Remains of old gaging station associated with 24-inch iron pipe that extends into the river.

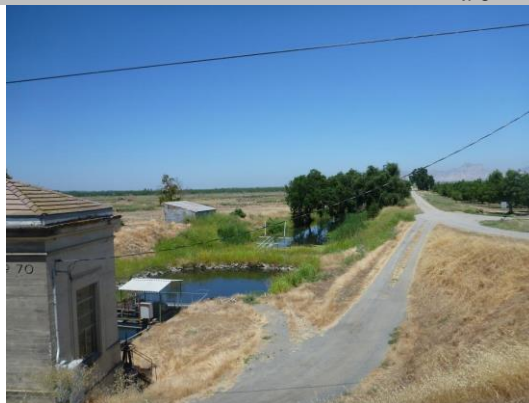
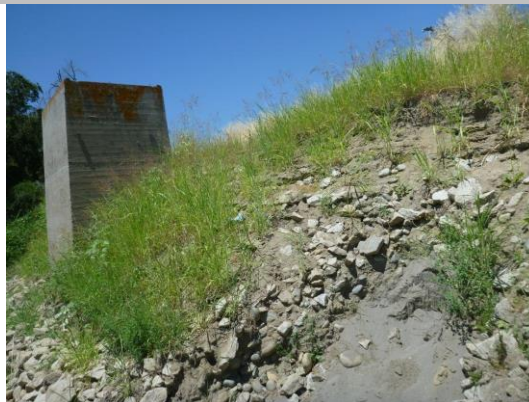
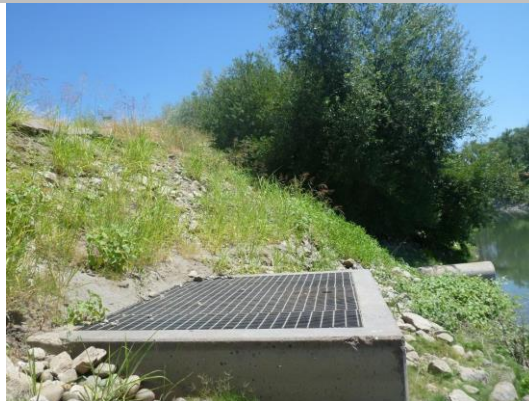
LM Start	13.83	Rating **	A/W	Issue No.	75
LM End	13.83	Issue Type +	Ma	Location *	
Category	Supplemental			GPS Latitude/Longitude	
				Start	End
Item	2017 Storm Damage			39.068190 °	39.068190 °
				-121.862700 °	-121.862700 °
DWR ID	DWR_RD0070_02_f_2017_75				
Comment Code					
Inspector Comment					
Levee Evaluation Comments					
Description:					
Site ID No:152					
Site Designation:RD 70-01					
Repair Type: Erosion					
Rating:Area of Concern					
Field Date:7/17/2017					
Notes: bank slope erosion around a drainage pipe/box

LM Start	13.83	Rating **	A/W	Issue No.	75 (cont)	
LM End	13.83	Issue Type +	Ma	Location *		
Category	Supplemental			GPS Latitude/Longitude		
				Start	End	
Item	2017 Storm Damage			39.068190°	39.068190°	
				-121.862700°	-121.862700°	
DWR ID	DWR_RD0070_02_f_2017_75					
Comment Code						
Inspector Comment						
Levee Evaluation Comments						
Description:						
Site ID No:152						
Site Designation:RD 70-01						
Repair Type: Erosion						
Rating:Area of Concern						
Field Date:7/17/2017						
Notes: bank slope erosion around a drainage pipe/box

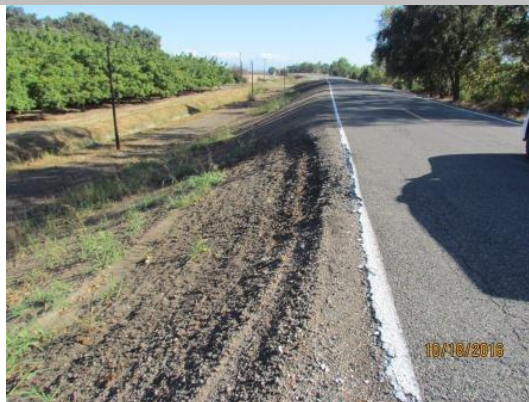
Photo 1 of 1 : SP_2018_RD0070_30_66_20180305_00013.jpg

LM Start	14.14	Rating **	M	Issue No.	66
LM End	14.14	Issue Type +	Ma	Location *	LS
Category	Earthen Levee			GPS Latitude/Longitude	
				Start	End
Item	Slope Stability			39.069849 °	39.069849 °
				-121.857267 °	-121.857267 °
DWR ID	DWR_RD0070_02_f_2016_66				
Comment Code					
S1 : Repair slope instability.					
Inspector Comment

View of slope instability along the landside slope.

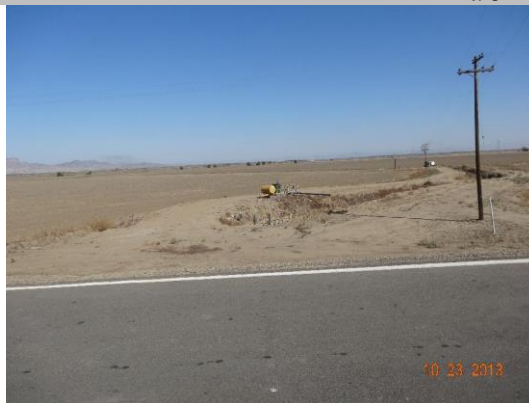
Photo 3 of 3 : UCIP_SP_2018_24229_42853.jpg

Item	DWR UCIP Field Study			39.065303 °	39.065303 °	
				-121.839230 °	-121.839230 °	
DWR ID						
Comment Code						
Inspector Comment						
FS_ID:24229						
DS_ID:21421						
EP_NO: 9990						
Repair Type: Non-Urgent						
Crossing Status: Found						
UCIP Comments: Need to determine if crossings are still being used.						
This crossing is referenced in the USACE Periodic Inspection as item						
USACE_CESPK_MRD2_2012_p_0685.						
FIELD_STRUCT_DESC: 1 of 2: 24-inch steel irrigation discharge pipe						
sleeved through a 30-inch coated steel pipe through the levee, 24 feet						
below the crown. Gate valve on the waterside (WS) end. Concrete						
headwall with a flap gate on the landside (LS). Pump on a pile structure						
in the stream. Wooden walkway to the pump. (Retention of two 24-inch						
steel pipes through the levee, 24 feet below the crown, two pumps, and						
two gate valves authorized under Automatic Board Order (ABO) issued

Overview of landward side.

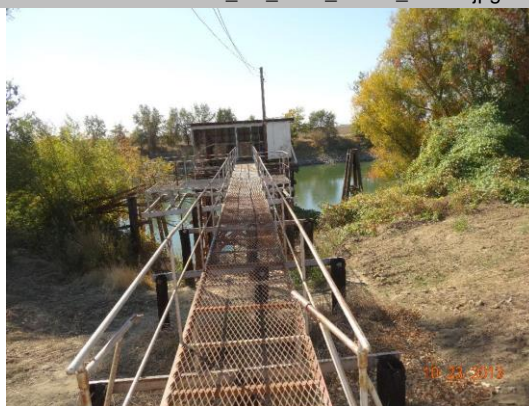
Photo 1 of 3 : UCIP_SP_2018_24230_42854.jpg

FS_ID:24230
DS_ID:21409
EP_NO: 9990
Repair Type: Non-Urgent
Crossing Status: Found
UCIP Comments: Need to determine if crossing is still being used. This crossing is referenced in the USACE Periodic Inspection as item USACE_CESPK_MRD2_2012_p_0685.
FIELD_STRUCT_DESC: 2 of 2: 24-inch steel irrigation discharge pipe sleeved through a 30-inch coated steel pipe through the levee, 24 feet below the crown. Gate valve on the waterside (WS) end. Concrete headwall with a flap gate on the landside (LS). Pump on a pile structure in the stream. Wooden walkway to the pump. (Retention of two 24-inch steel pipes through the levee, 24 feet below the crown, two pumps, and two gate valves authorized under Automatic Board Order (ABO) issued as Permit No. 9990, 1974 - Newhall Land and Farming Company).
[Additional Reference(s): DWR Levee Log, 2007. USACE Sacramento O&M Manual 134, June 1953, (Station 1086+55)].
FS Date: 10/23/2013

Walkway and Pump house located on waterward side.
